EVALUATION OF CONCRETE BY ULTRASONIC TESTING, F. E. WARREN AUXILIARY SITES, SQUADRON III

H. T. Thornton, Jr.

MISCELLANEOUS PAPER NO. 6-585

July 1963

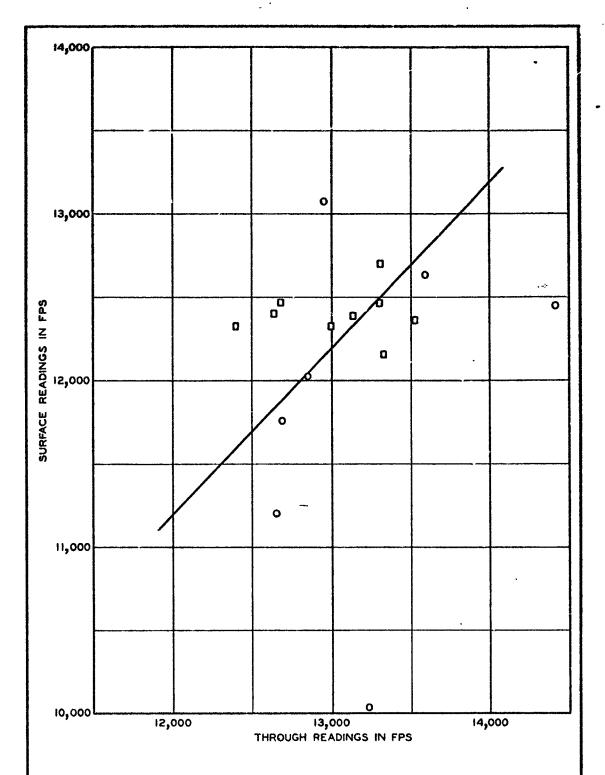
- 19. The test results indicate that the different aggregate sources had an effect on the pulse velocity-compressive strength relation, but did not cause major variations in the comparative results.
